# Vulnerability of Multistory RCC Framed Building with Shear Wall During Fire

Fire in a building is a casual phenomenon but cannot be completely ruled out in spite of the facts that buildings are provided with mandatory fire safety measures. A symmetrical in plan with 5 bays with 20 stories regular RCC building has been considered with fire at three different level that is at the bottom, middle and top. The building has been designed for gravity loads and lateral loads having three different configuration of shear walls and columns. Fire temperature of 700 °C was considered. The minimum value of maximum fire temperature for failure of vertical members has been found out by iterations. The worst verticals members due to fire has been identified and their displacement calculated. Best location of shear walls using commercial software etabs is used for the analysis and design.

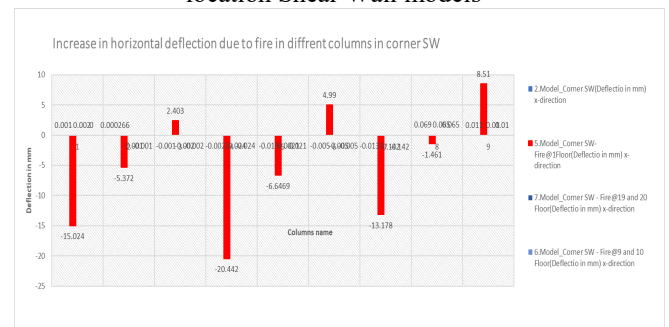
Figure (9): Horizontal deflection at first floor in different columns in corner SW
